4.7 CANAL PRISMS

4.7.2 Existing Conditions & Deficiencies

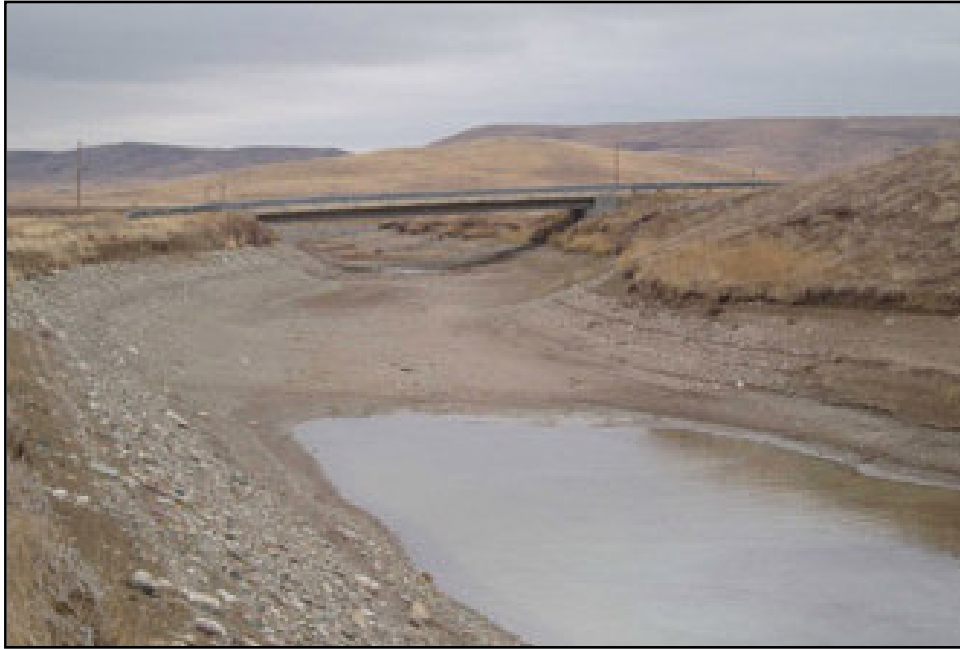
Figure 4.7.1 Looking downstream at Martin Road Bridge (11/11/04).

8. *Slope.* The bottom slope of the canal is irregular. The invert has ups and downs that cause obvious ponding at low flows. This irregular slope decreases the efficiency of the canal in two ways. First it causes irregular cross sectional areas that are constantly creating contracting or expanding flow conditions. These conditions reduce canal capacity compared with a consistently shaped invert. Examples of an irregular slope are shown in Figures 4.7.1, 4.7.2 and 4.7.7.

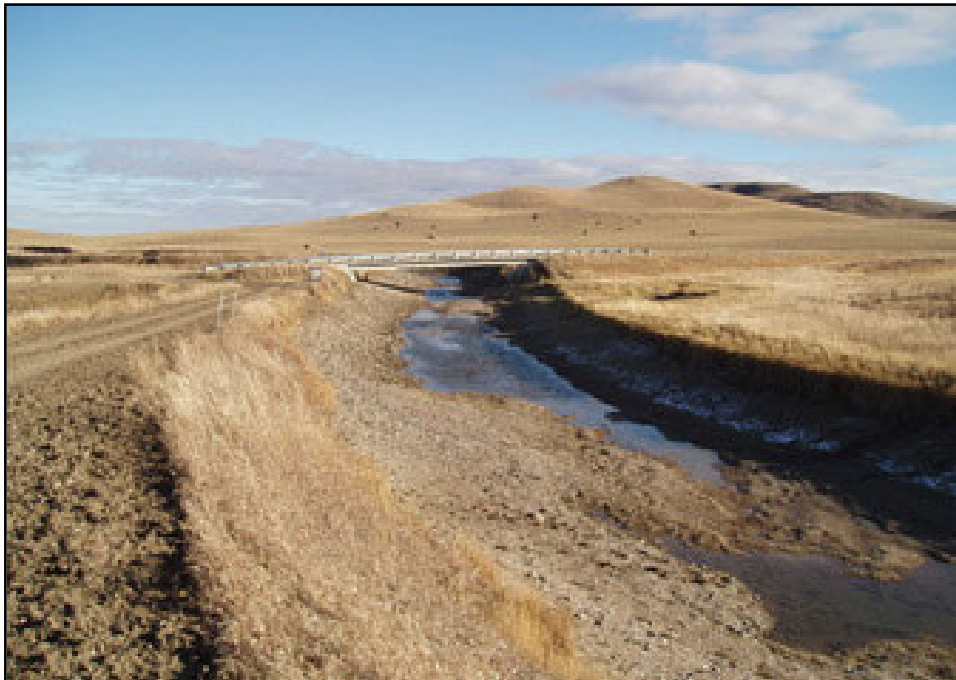
Figure 4.7.2 Looking downstream at Emigrant Gap Road Bridge (11/11/04).

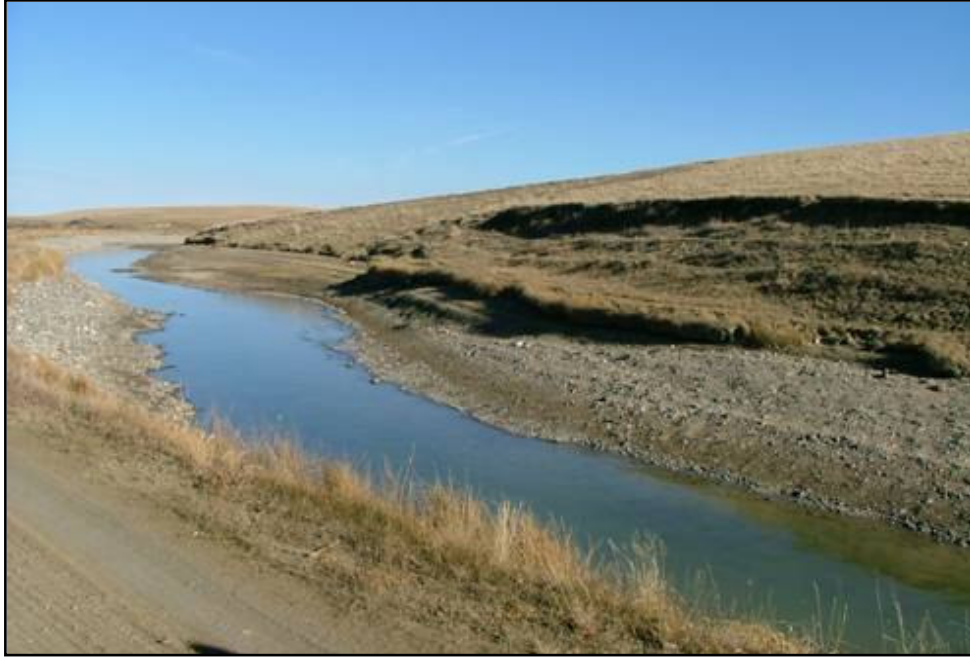
- **Reduced Capacity** - The BOR reports that the canal has an available capacity of 850 cfs between the diversion dam and the inlet to the St. Mary River Siphon but only 670 cfs downstream of the river crossing. Based on current canals flows of 670 cfs, we did not observe sufficient and continuous freeboard upstream to support a claim of 850 cfs capacity upstream of the St. Mary Siphon. Canal capacity decreases have occurred because of prism degradation, sedimentation, erosion, encroaching upslope landslides, and settlement of fill sections. Figure 4.7.3 shows the effect of slope instability on the canal prism and reduced flow area, i.e. capacity.

Figure 4.7.3 Typical earth slide encroaching into canal prism and reducing capacity (11/11/04).

6. *Sinuosity*. Numerous curves exist in the canal alignment. Each curve causes a loss of hydraulic momentum, which reduces the overall capacity. Minimizing the curves is recommended for any future canal improvements. Also, increased sinuosity increases both erosion and deposition within the canal prism. Erosion can increase instability issues of the canal side slopes. Examples of inefficient canal alignment (sinuosity) are shown in Figures 4.7.3 and 4.7.11.

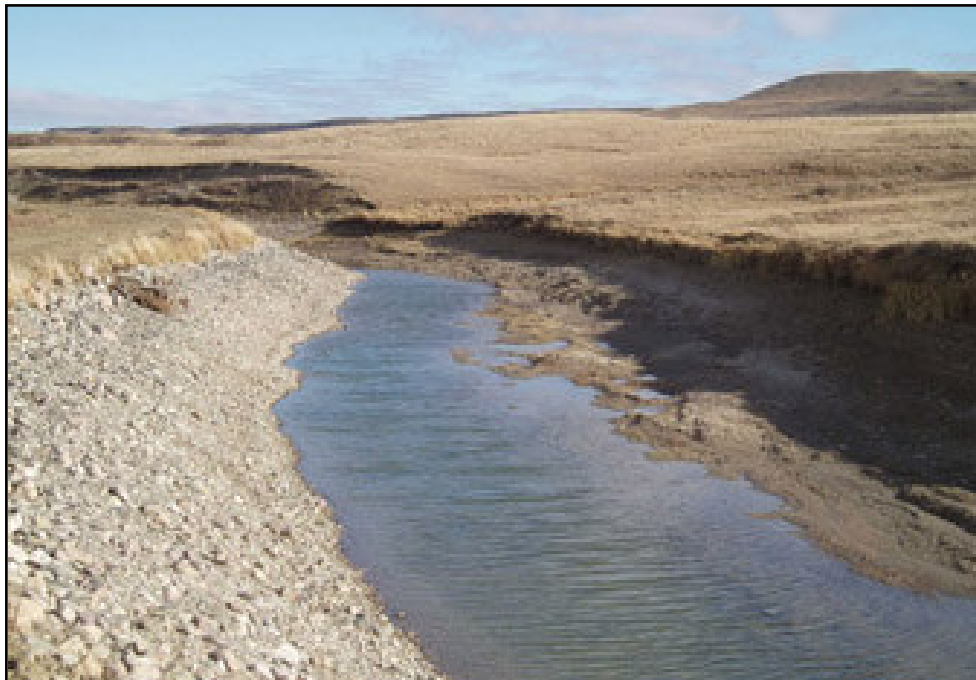
Figure 4.7.4 Looking downstream at typical canal prism. Note irregular cross-section, erosion of right bank, relatively recent armoring on left bank and slope failure in background (11/10/04).

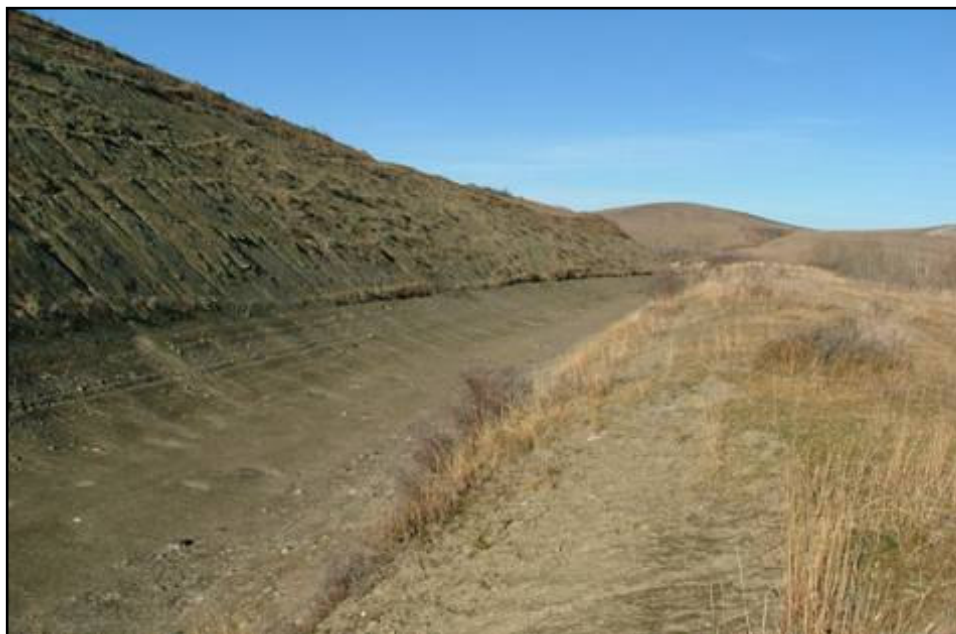
Figure 4.7.5 One-bank canal section downstream of St. Mary River Siphon. This reach is excavated into bedrock and is stable (11/11/04).

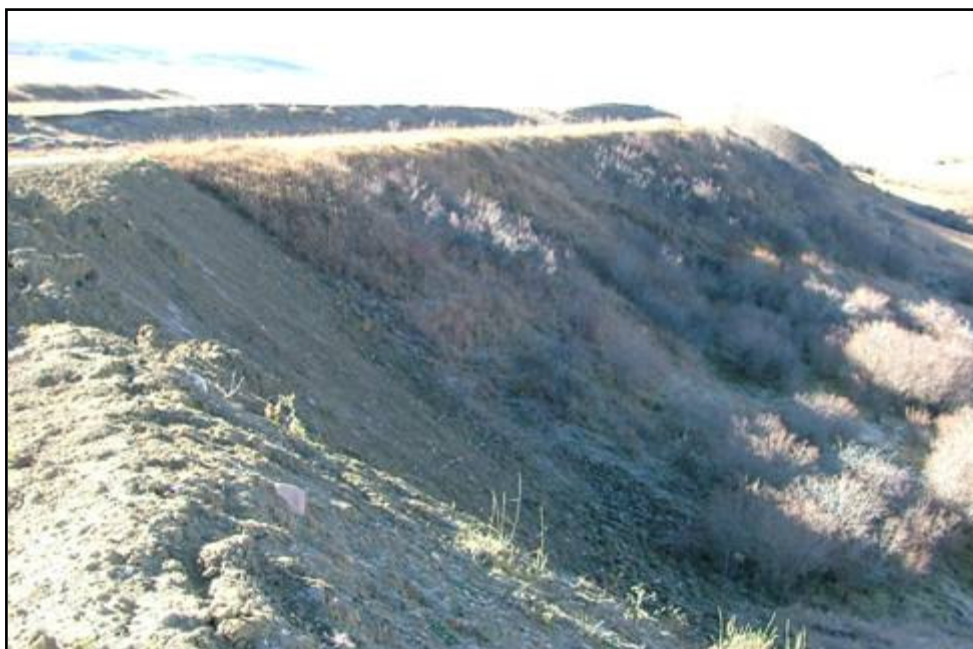
Figure 4.7.6 Typical fill-section of canal at edge of coulee downstream of Spider Lake check structure (11/11/04).

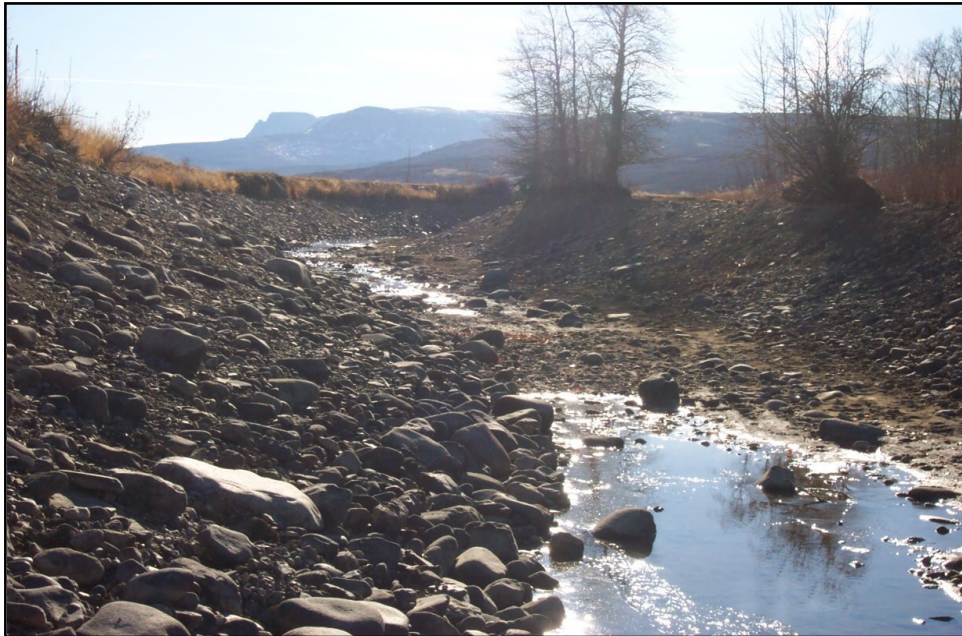
- **Seepage Losses** - Seepage losses are observed along the entire length of the canal. However, the first 6 miles of canal most likely accounts for the majority of the seepage losses. Native soils consist of coarse alluvial fan deposits of Swiftcurrent and Kennedy Creek. Past the St. Mary River Siphon, soils are typically fine-grain glacial till and glacial drift soils. The BOR reports between 70 and 80 cfs is lost due to seepage between the diversion dam and the inlet of St. Mary River Siphon. Seepage losses reflect conveyance efficiency and contribute to fill section instabilities. Figure 4.7.8 shows typical material associated with alluvial fan deposits, which are prone to high seepage losses.

Figure 4.7.7 Rocky channel bottom decreases hydraulic capacity. This highly permeable material is typical of alluvial fan deposits associated with Swiftcurrent and Kennedy Creeks (11/11/04).

been reported in the first 9 miles of the canal. Figure 4.7.7 shows typical material prone to high seepage losses.

7. *Roughness.* The roughness of the channel varies along its length and its cross section. Some areas are very rough and rocky while others are relatively smooth. The overbanks contain combinations of grass, bare soil, rocks, and brush. The BOR assumes a Manning's roughness of 0.0225 for new canals. An example of high surface roughness is shown in Figure 4.7.7.

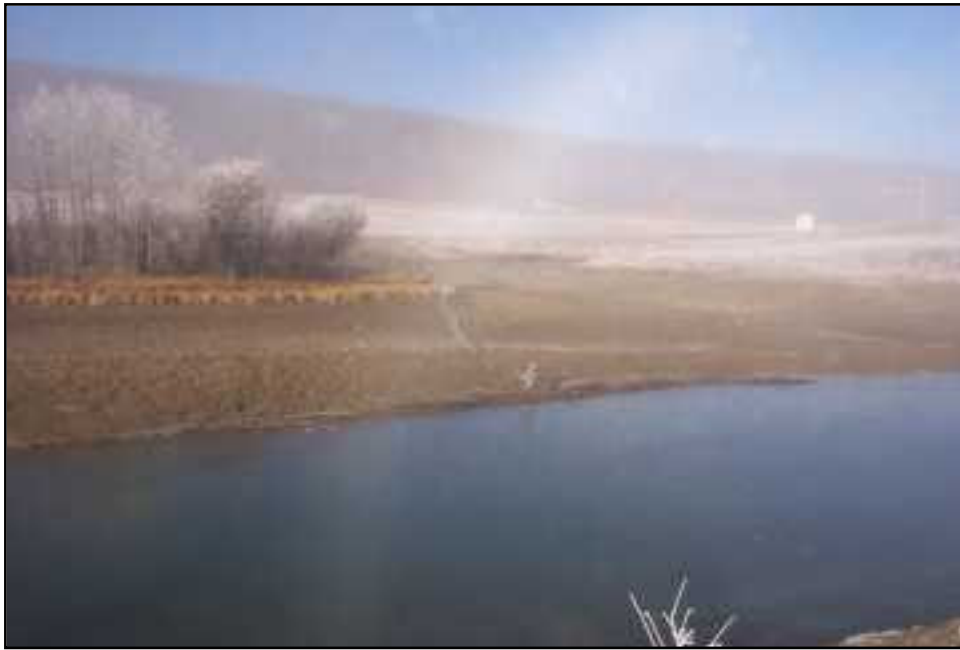
1. *Canal Shape*. Irregular cross-section over much of its length decreases flow capacity. At many locations only one embankment was installed during canal construction. The west side of the canal includes a left overbank at many locations that expand the canal to many times its normal width. Figure 4.7.8 shows an example of an irregular cross-section.

Figure 4.7.8 Example of irregular canal prism cross-section (11/11/04).

Each time that the canal shape expands or contracts it reduces flow capacity. All other things being equal, the canal capacity will increase if the shape is constant. In order to achieve a constant shape, a defined embankment would need to be installed on both sides along the entire canal (i.e., two-bank construction). Installation of a left embankment will require that local drainage (inflow) into the canal be addressed.

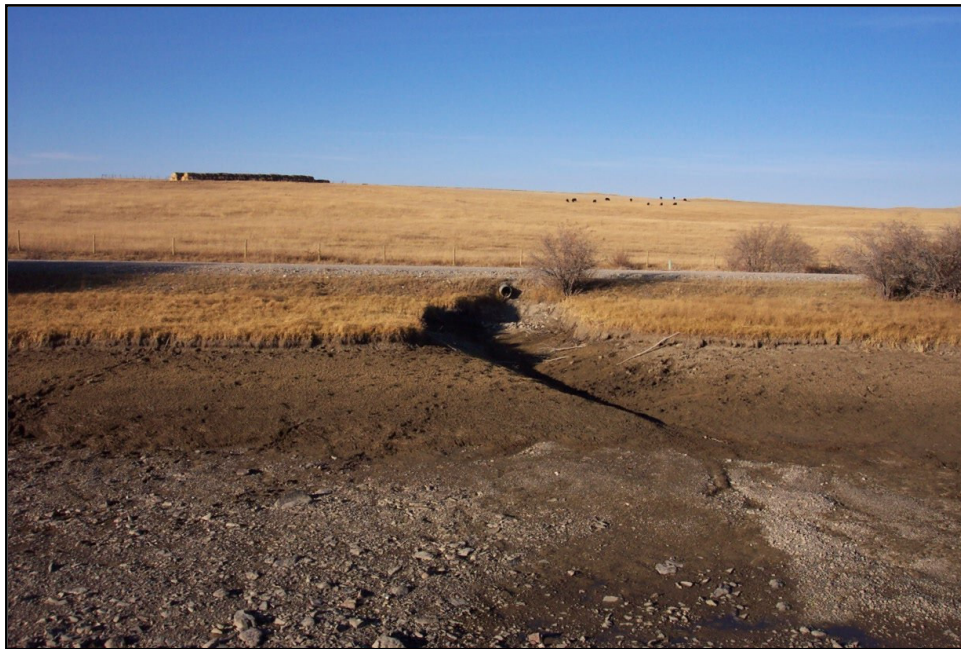
4. *Local Runoff.* Some fairly large drainage areas contribute runoff directly into the canal. In general, little or no erosion protection has been provided at drainage culverts that divert water into the canal. As a result, severe erosion has occurred at numerous locations.

Figure 4.7.9 Severe inflow erosion at drainage culvert (11/11/04).

While addition of water to the canal may be beneficial under certain circumstances, it can be a major problem at other times. The canal should either be oversized with sufficient free board to carry the additional inflows with overflow or wasteway structures used for emergencies, or under-flow, cross-drainage beneath the canal should be provided. The former is preferred.

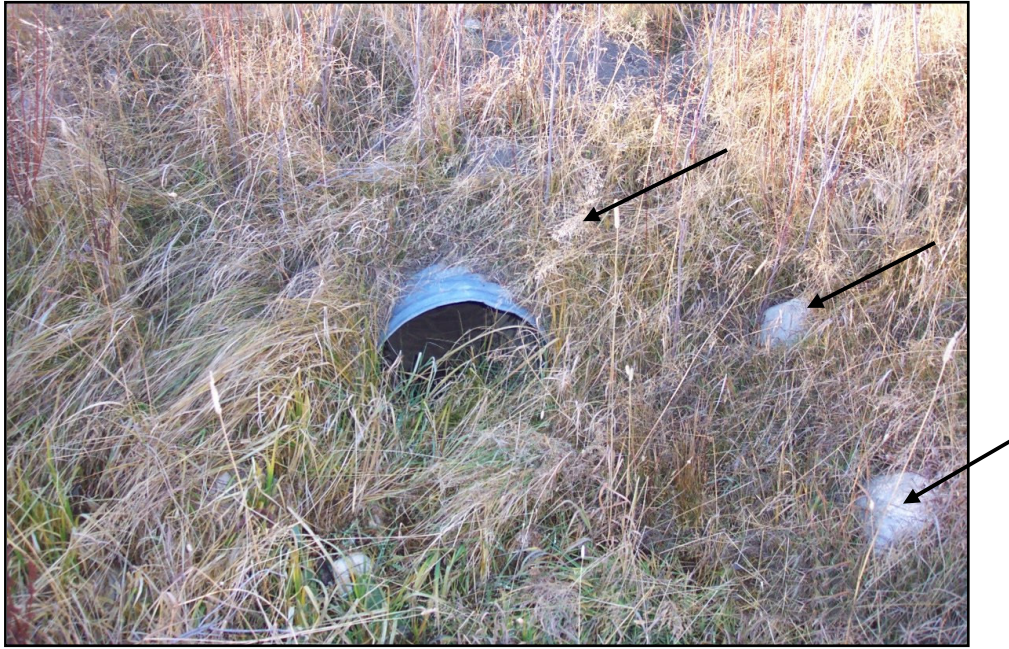
5. *Groundwater Piping.* Groundwater piping was evident at a few locations. At a couple of areas inside the canal, piping was obvious. This is indicative of upgradient groundwater entering into the canal. In general this type of piping should not be of serious concern. However, it would need to be addressed if a liner were to be installed inside the canal. At one

location groundwater piping was noted on the exterior embankment. This is of greater concern; since it is likely evidence that groundwater is leaking out of the embankment at a high enough rate that it is carrying sediment out of the embankment. Over time this could lead to embankment failure. An example of piping, most likely associated with construction of a drain turnout, is shown in Figure 4.7.10.

Figure 4.7.10 Piping on fill bank near existing drain turnout. Note areas of ongoing piping. (11/11/04).

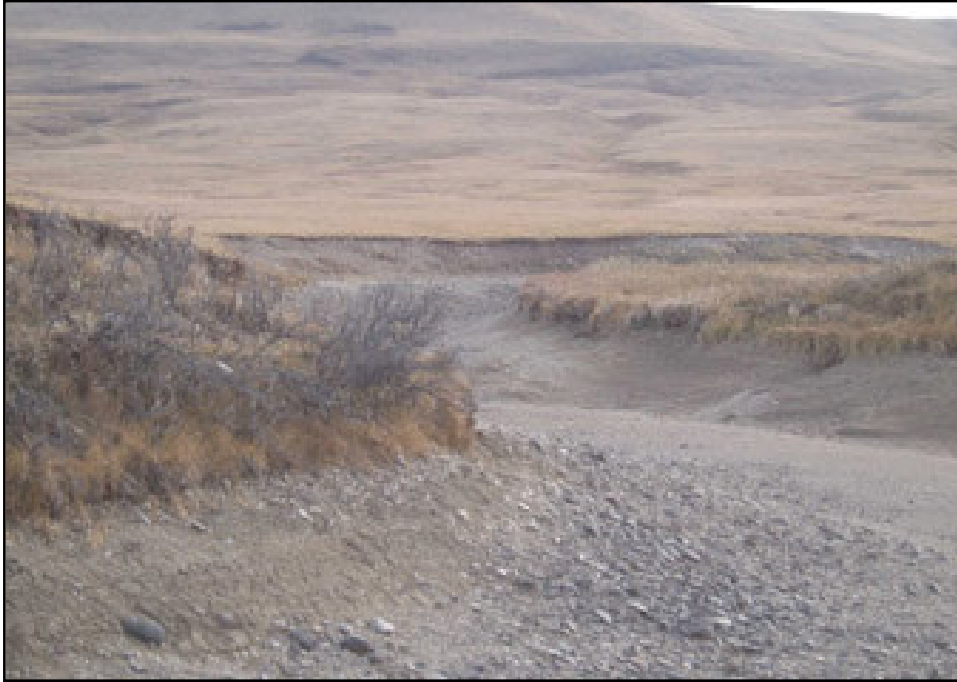
Figure 4.7.11 Typical canal section showing sinuosity inherent to contour canals in rolling terrain (11/11/04).
